INSPECTION REPORT

4405 WEST GULF DRIVE
SANIBEL, FL 33957

02/14/2023

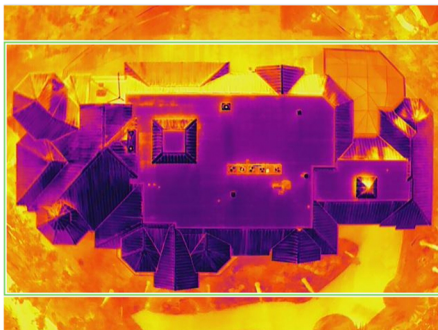
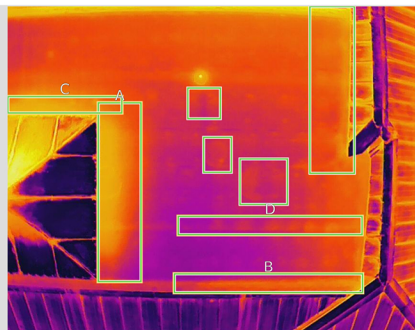
AT008

CONFIRMED DAMAGE
 Ponding Water

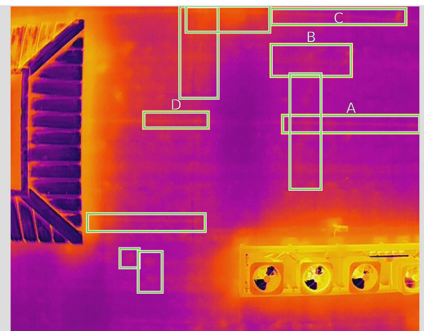
AT032

CONFIRMED DAMAGE

Ponding Water

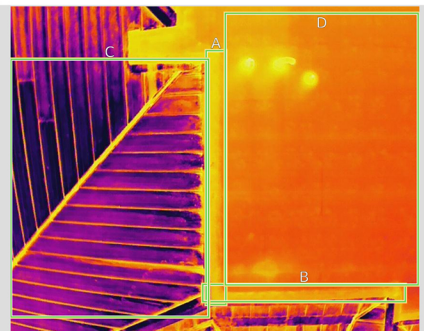
AT042

CONFIRMED DAMAGE

Ponding Water

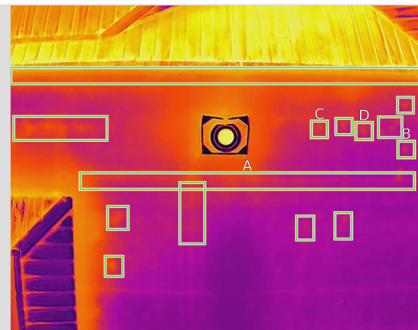
AT034

CONFIRMED DAMAGE
 Ponding Water

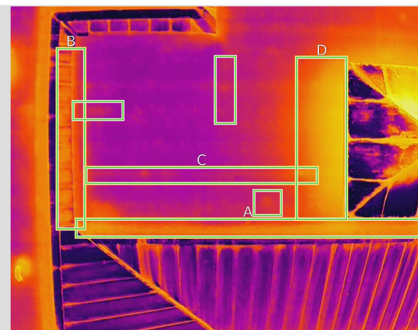
AT016

CONFIRMED DAMAGE
 Ponding Water

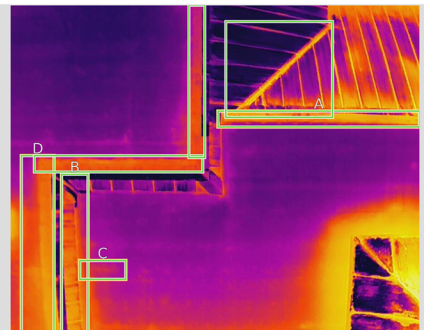
AT018

CONFIRMED DAMAGE

Ponding Water

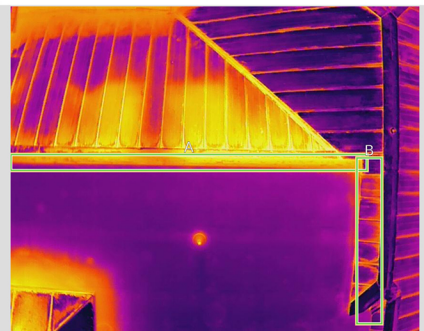
AT010

CONFIRMED DAMAGE

Ponding Water

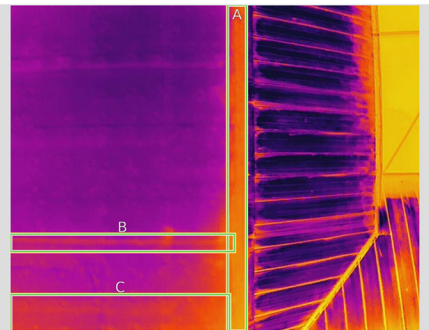
AT020

CONFIRMED DAMAGE

Ponding Water

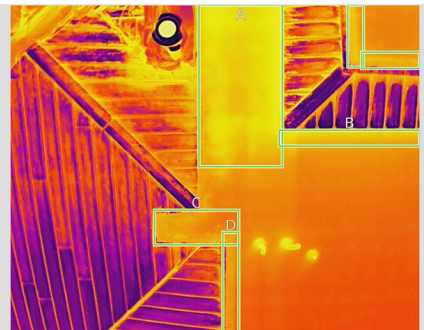
AT044

CONFIRMED DAMAGE
 Ponding Water

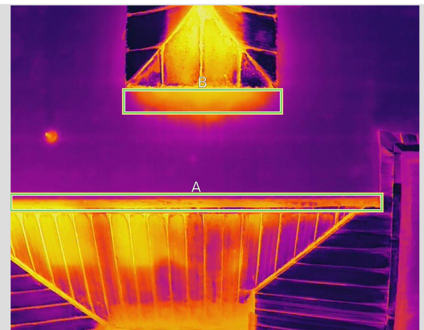
AT012

CONFIRMED DAMAGE
 Ponding Water

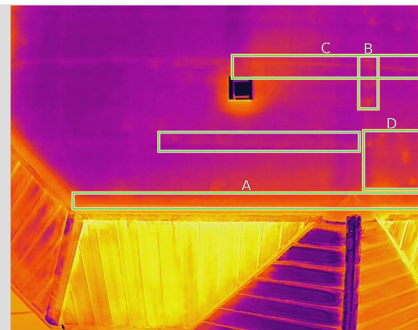
AT024

CONFIRMED DAMAGE
 Ponding Water

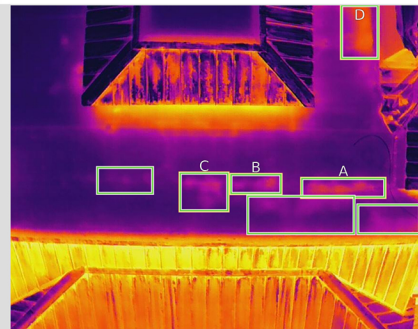
AT036

CONFIRMED DAMAGE
 Ponding Water

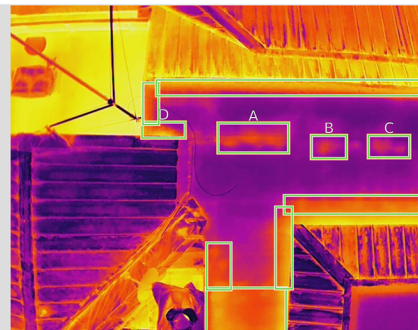
AT048

CONFIRMED DAMAGE

Ponding Water

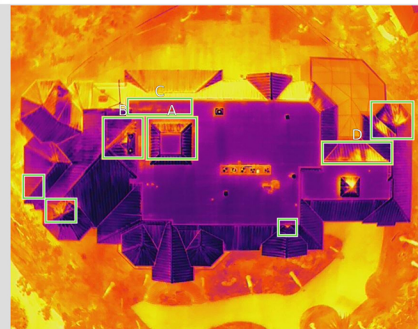
AT002

CONFIRMED DAMAGE

Ponding Water

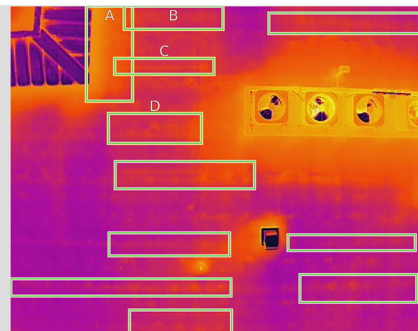
AT030

CONFIRMED DAMAGE
 Ponding Water

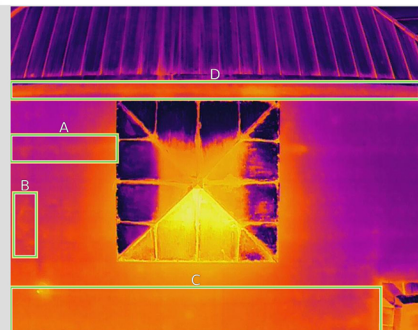
AT014

CONFIRMED DAMAGE
 Ponding Water

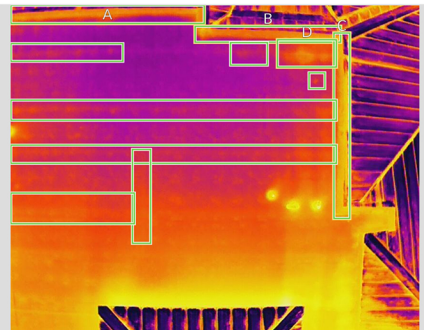
AT040

CONFIRMED DAMAGE

Ponding Water
