INSPECTION REPORT

10/27/2022

Inspection Report Summary

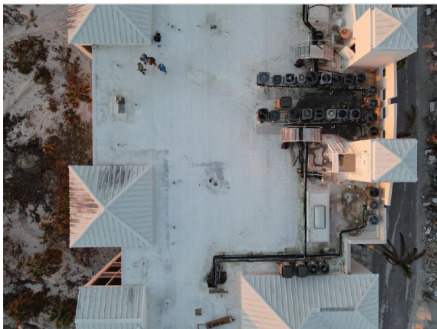
AT001

The "hot spots" described in the report are reading temperatures 2-4 deg C, higher than the surrounding areas. Water intrusion is likely in those areas.

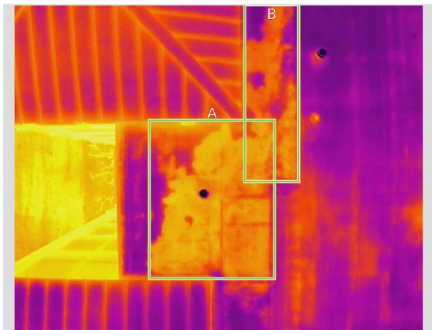
AT003

A,B- "Hot Spot" in the field of the membrane, water intrusion likely. Reading 23.5C surrounding area is 20.1C. Physical interactions with this area lead us to believe it's heavily saturated.

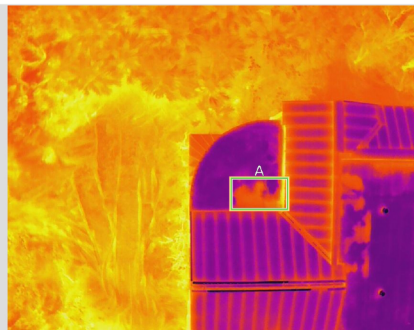
AT016

A- "Hot Spot" in the field of the membrane, water intrusion likely. Reading 23.5C surrounding area is 20.1C.

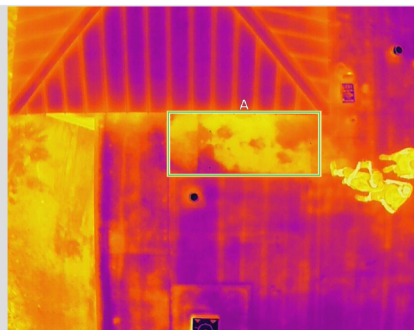
AT010

A- "Hot Spot" in the field of the membrane, water intrusion likely. Reading 23.5C surrounding area is 20.1C. Physical interactions with this area lead us to believe it's heavily saturated.

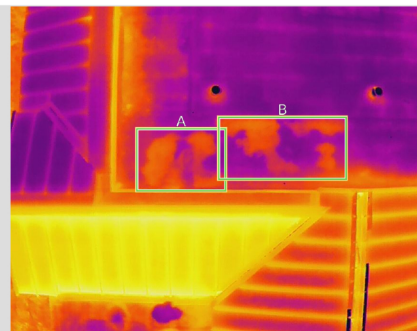
AT007

A,B- "Hot Spot" in the field of the membrane, water intrusion likely. Reading 23.2C surrounding area is 20.3C.

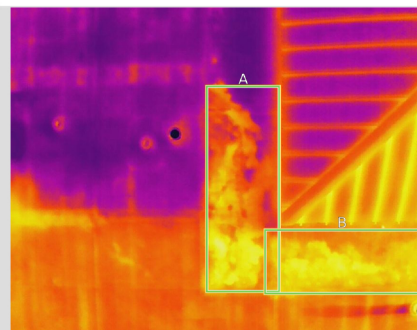
AT004

A- "Hot Spot" in the field of the membrane, water intrusion likely. Reading 23.5C surrounding area is 20.1C. Physical interactions with this area lead us to believe it's heavily saturated.

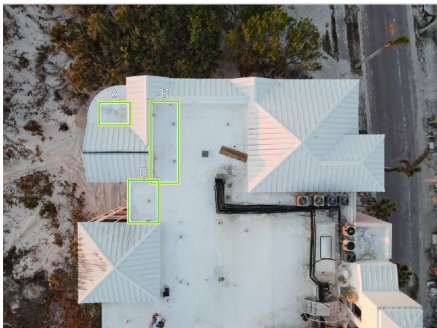
AT017

A,B,C- "Hot Spot Locations" Physical interactions with this area lead us to believe it's heavily saturated. Areas around mechanical equipment (ACs & Water Pipes) are unable to have accurate thermal readings however ponding water and the multiple penetration's in those areas are likely saturated.
