INSPECTION REPORT

10/27/2022

Inspection Report Summary

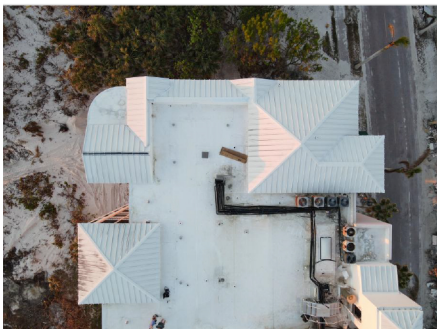
AT017

The "hot spots" described in the report are reading temperatures 2-4 deg C, higher than the surrounding areas. Water intrusion is likely in those areas.

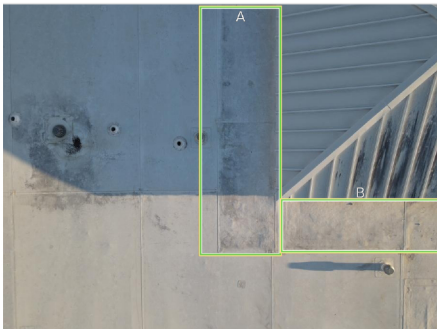
AT018

CONFIRMED DAMAGE
